Manhole Inspection Summary

Manhole # S49K__025MH

Insp Date: **3/27/08 10:41 AM**

Location Address: **700 rose**

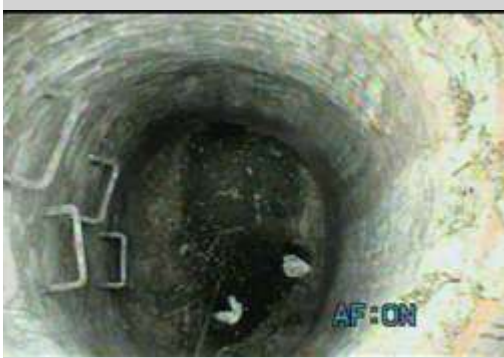
Defect 1

Condition: ☐ Sound ☐ Cracked ☐ Root Intrusion ☐ Loose Brick ☒ **Deteriorated**

Condition: ☐ Sound ☐ Cracked ☐ Root Intrusion ☐ Deteriorated ☐ Leaks ☒ **Debris**

Count: **5** Missing: **0** ☒ **Corroded**

Channel Debris, steps corroded, corbel deteriorated

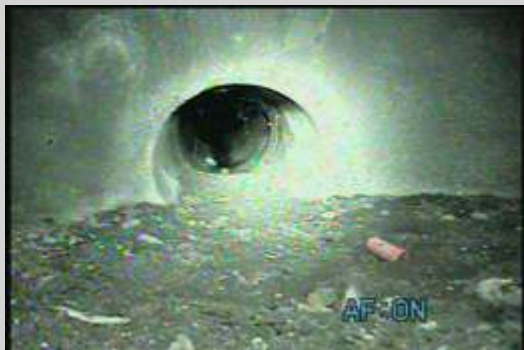
12 O'Clock Outflow

8 in. Circular Gravity Sewer
Pipe Out @ 12 O'Clock

Deposits: ☒ None ☐ Mud ☐ Sludge ☐ Debris ☐ Grease

Infiltration: **None** Pipe Seal Cond: **Unknown**
